HOUSATONIC RIVER BASIN  
LEE, MASSACHUSETTS

LEAHEY (UPPER) RESERVOIR DAM  
MA 00265

PHASE I INSPECTION REPORT  
NATIONAL DAM INSPECTION PROGRAM

FEBRUARY 1979

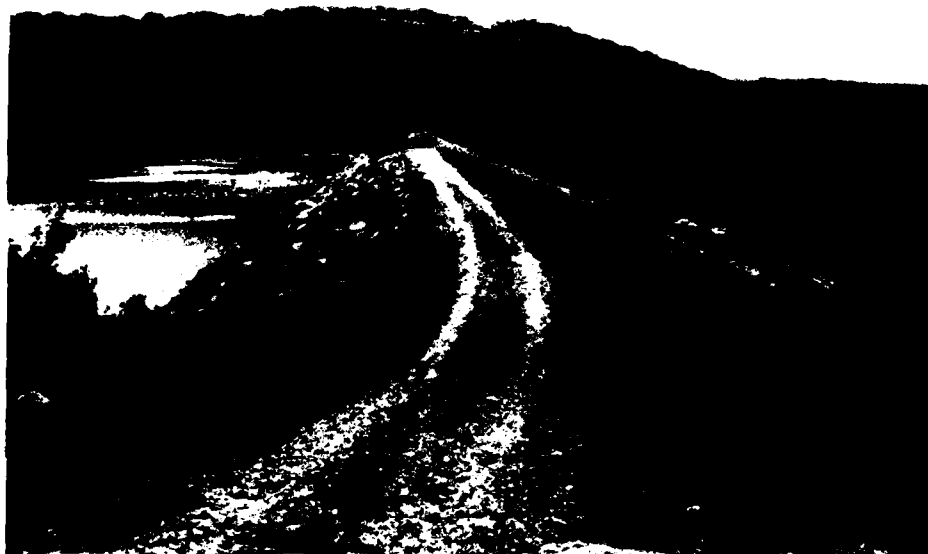
1. OVERVIEW OF DAM FROM RIGHT ABUTMENT.

- (4) The wheel ruts of the roadway across the dam crest as shown in Photo No. 1 offer some potential for local erosion if they cause concentrations of runoff flow down the dam slope.

- (4) Fill the wheel ruts in the crest of the dam with compacted gravel and grade to a uniform cross-section.
  - (5) Replace the riprap protection on the upstream slope of the dam adjacent to the left abutment and where needed. Riprap bedding layers in these areas (see Appendix B-17) should be checked and if eroded, should be restored.

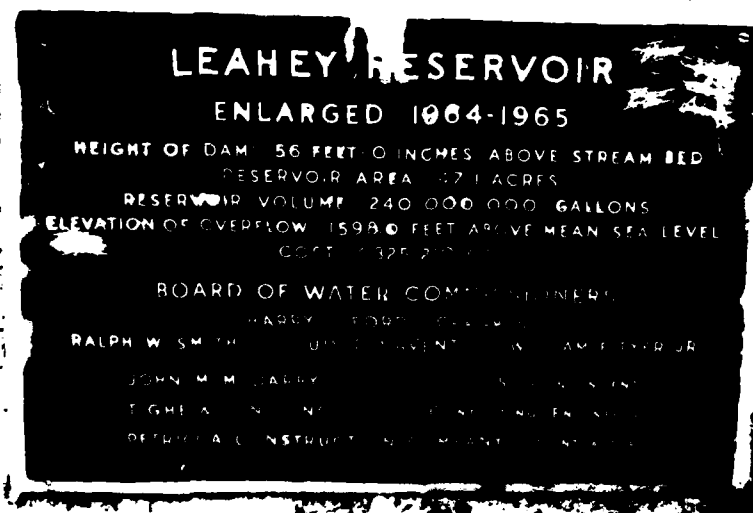
2. PLAQUE ON GATE HOUSE EXTERIOR.

The elevations on the design plans and the plaque on the gatehouse are marked as on mean sea level datum. It should be noted, however, that the spillway crest is stated as Elevation 1598.0 while the U.S.G.S. Quadrangle, East Lee, Massachusetts, shows the reservoir surface at Elevation 1,609. All elevations shown in this report are based on the elevations shown on the record plans for the dam and spillway.

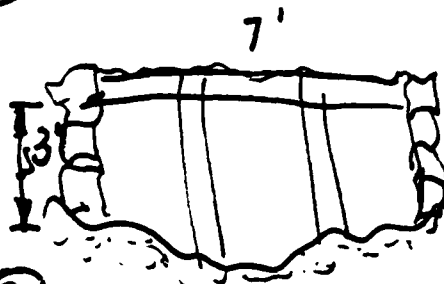
①

7' wide x 3' high stone box  
with 6" x 6" wood posts  
L = 10' ±

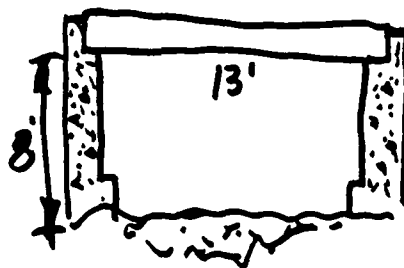
②

8' high x 13' wide opening. Concrete  
abutments with steel girder spanning  
L = 12' ±

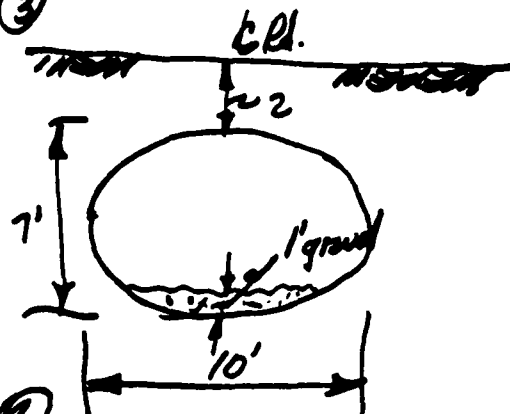
③

10' x 7' multi plate arch  
L = 25'

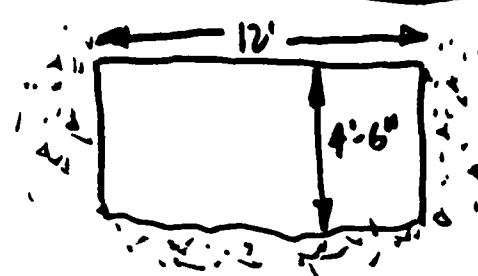
④

12' wide x 4'-6" high conc. box  
culvert L = 30' (1932)  
2nd culvert just u.s. 14' x 4.5' h.  
C. corr. rd. box. L = 20'

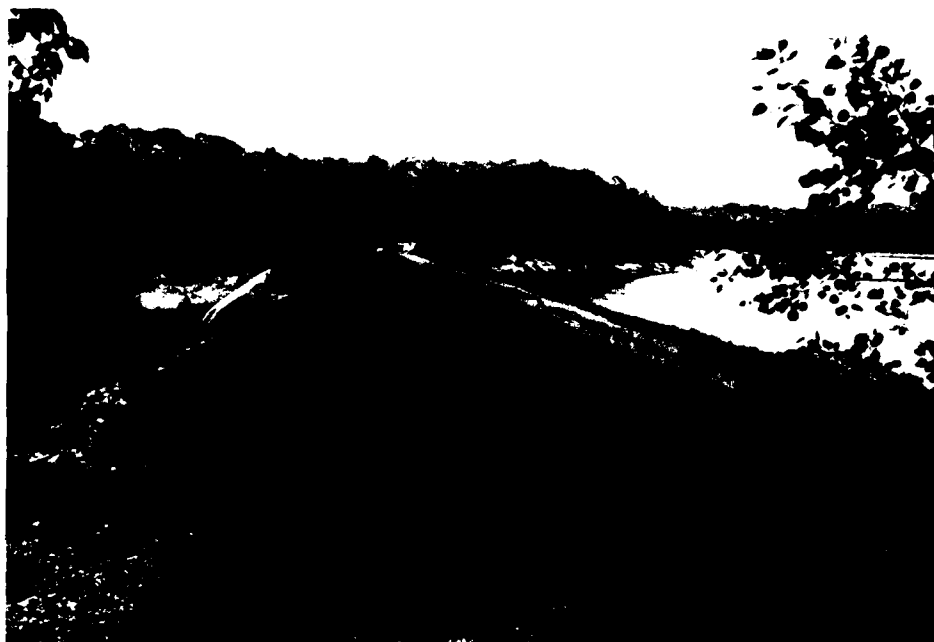
- (2) There were two other locations of slight seepage with rust staining in the area at the toe generally below the 12-in. CMP outlet.
- (3) The downstream slope to the extreme toe below the access road as shown in Photo Nos. 3, 7 and 10 has a heavy growth of grass, weeds, brush and young trees, plus some old cuttings, making examination for seepage difficult.

3. OVERVIEW OF DAM FROM LEFT ABUTMENT.

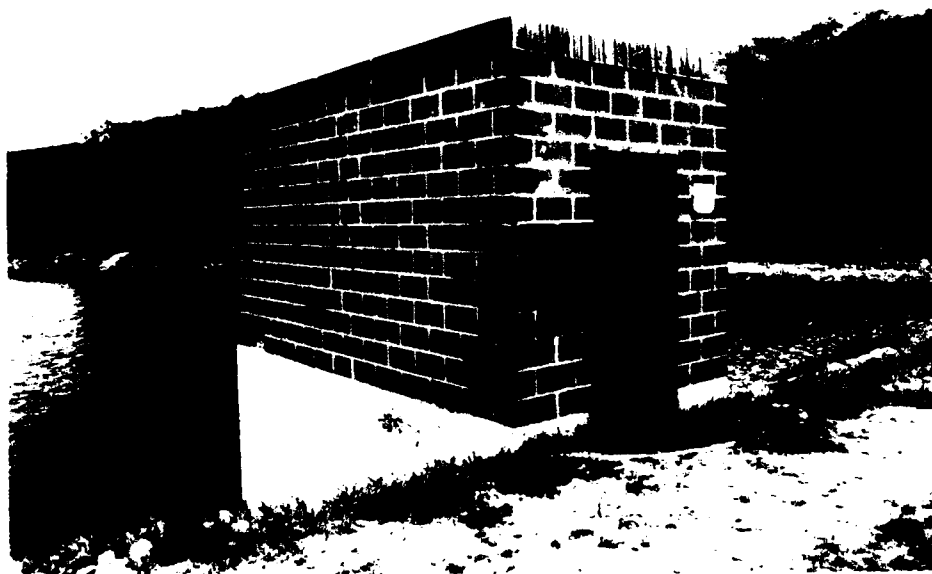
The gatehouse substructure appeared to be in good condition. The concrete block superstructure, shown in Photo No. 5, is chipped at the northwest corner of the building and there is a crack present in the joints of the south wall of the building. The door is starting to show some signs of rust. Bullet impressions are present in the door as well as in the exterior walls of the gatehouse. The interior of the gatehouse, as shown in Photo No. 6, is in good condition. The six manually operated gate valves are operational. The overhead chainfall is operational; however, some rusting is starting to occur on the chainfall beam. Wooden covers are present over the hatch openings. The outlet of the reservoir drain from the gatehouse has no formal structure. As shown in Photo No. 9, the outlet end of the drain is protected by stones placed over the pipe.

5. GATE HOUSE AT UPSTREAM FACE OF DAM.

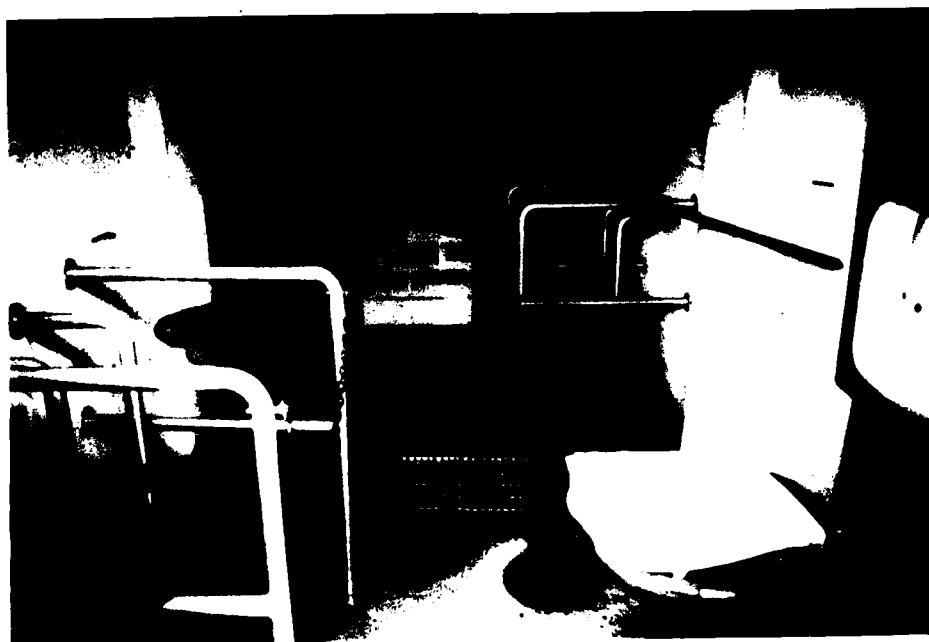
6. INTERIOR OF GATE HOUSE.

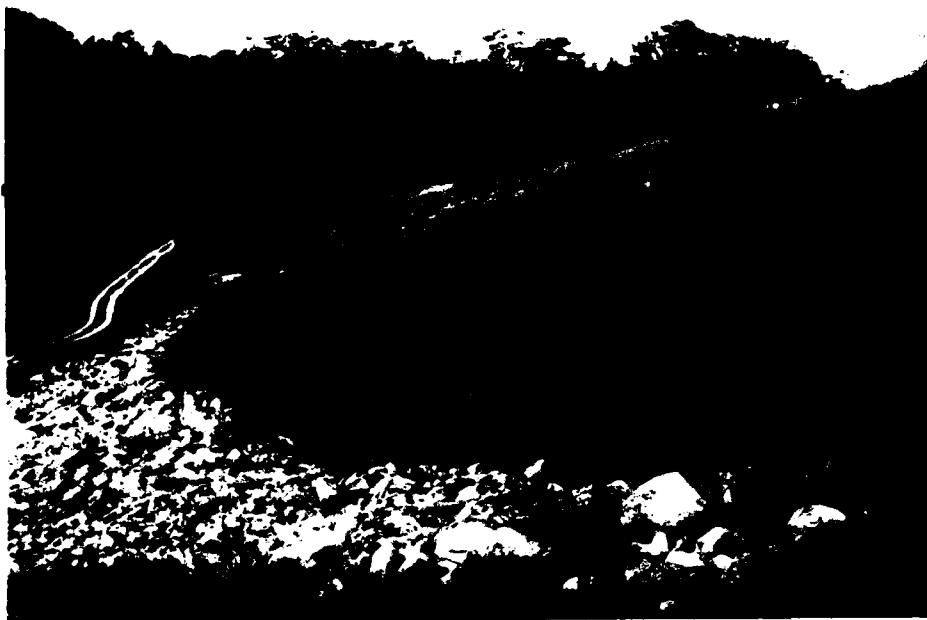
7. ROCK AT THE TOE OF DAM.
